# **Pearson Creek Stream Restoration Plan**

By  
Heart-Bar-Heart Ranch  
Montana Fish, Wildlife & Parks  
USFWS Partners for Fish & Wildlife  
Big Blackfoot Chapter of Trout Unlimited

August 2012

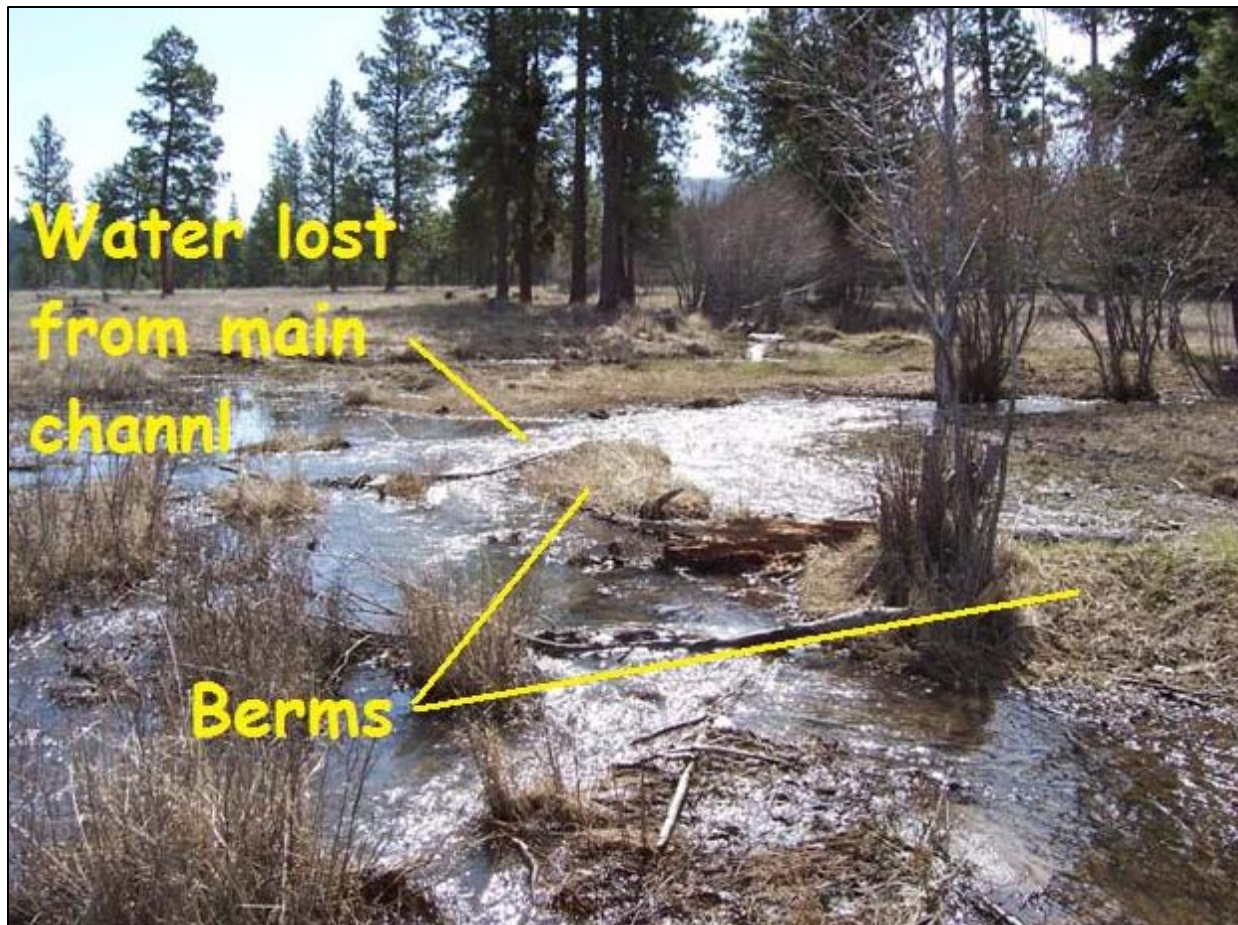
**Photo 1:** This photo shows a section of Pearson Creek where channelization and berms are impacting the stream. Notice the loss of water from gaps in the berm.

Channel restoration is required on a 1,244 foot section of Pearson Creek that has been bermed and is also entrenched in sections (Photo 1 & Figure 2). The bermed channel drains into a

To meet the restoration targets, four project elements have been identified. These include 1) the reconstruction of 1,244 feet of new channel where the stream is currently channelized and bermed (Photo 1), 2) the replacement of the undersized culvert to restore aquatic organism passage at all ranges of flow and correct improper road drainage conditions (photo 5), 3) riparian revegetation using native woody plants, and 4) grazing management changes that include riparian fencing to protect and improve cutthroat trout habitat.

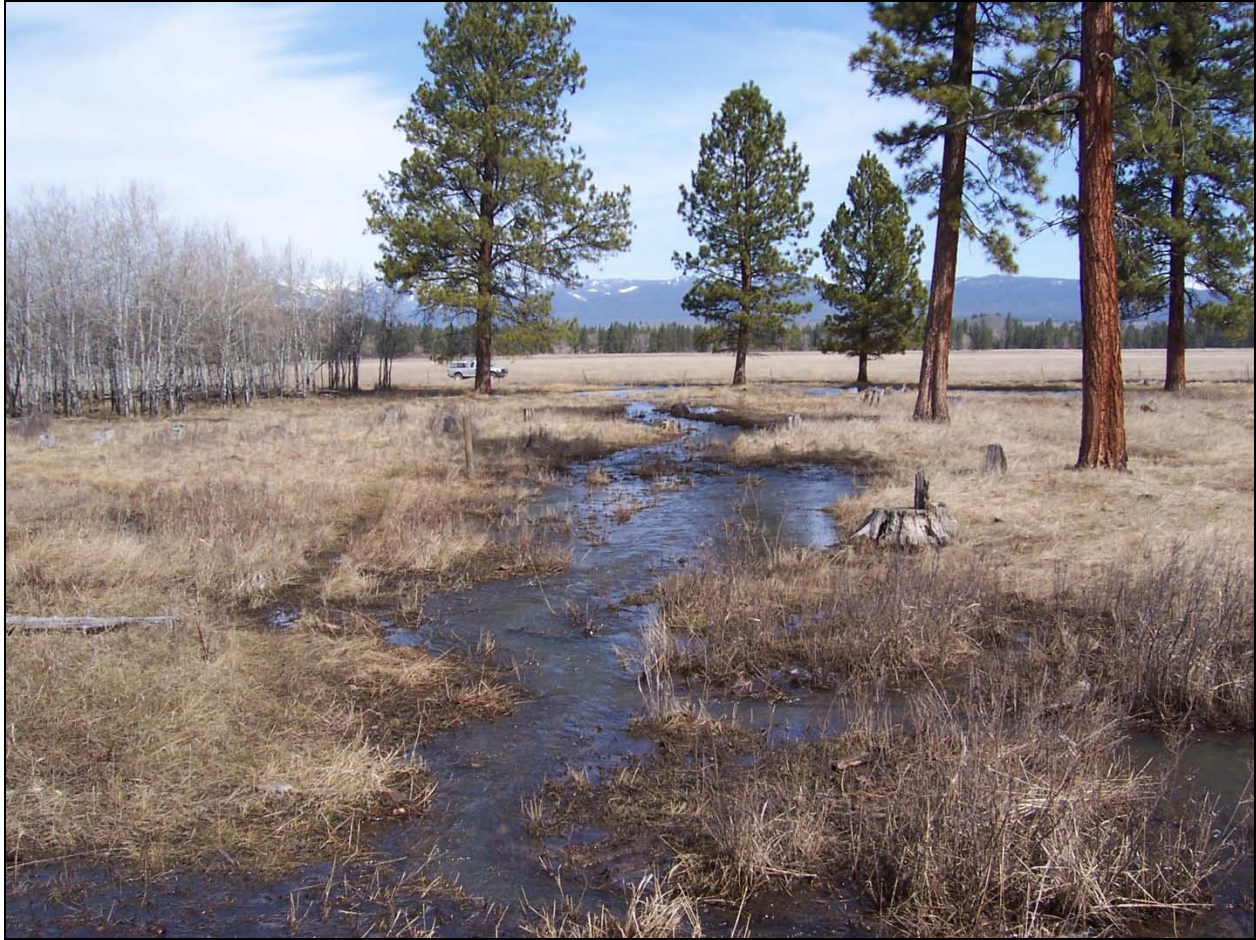
**Photo 2:** This photo shows water lost from the main (i.e., perched) Pearson Creek channel during the spring runoff. The proposed new channel will be constructed within this channel, which is likely a segment of the historical channel.

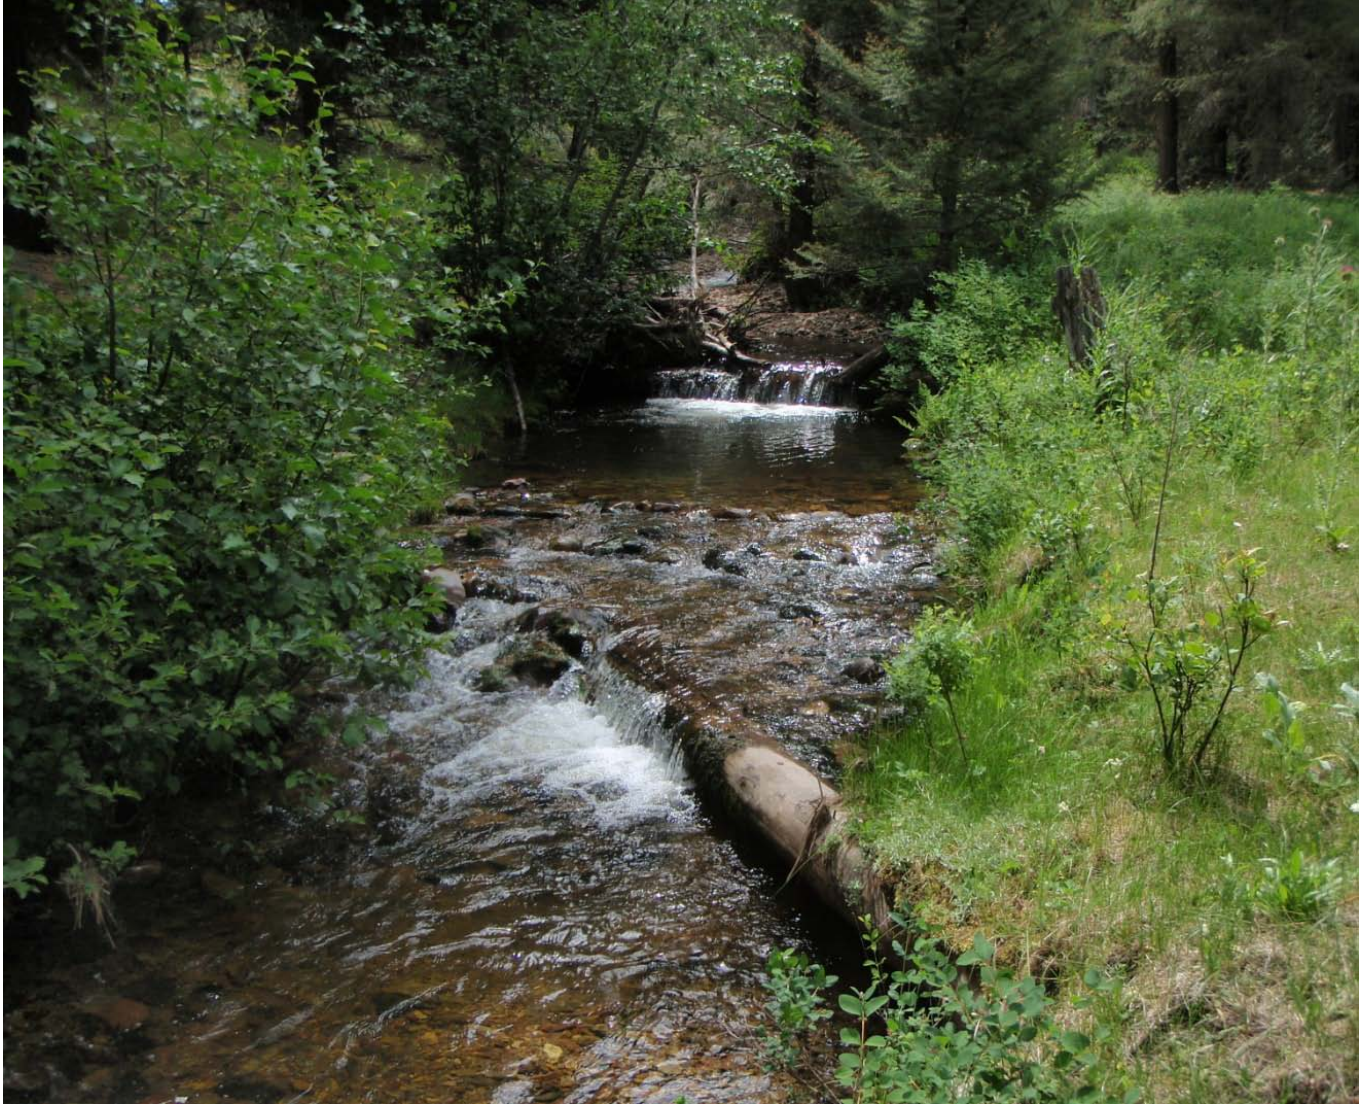
**Photo 3.** Photo of the upstream reference reach taken in July, 2011. The upper (i.e., B-channel) portion of the new channel will have step-pool morphology using instream wood features typical of a small forested mountain stream.

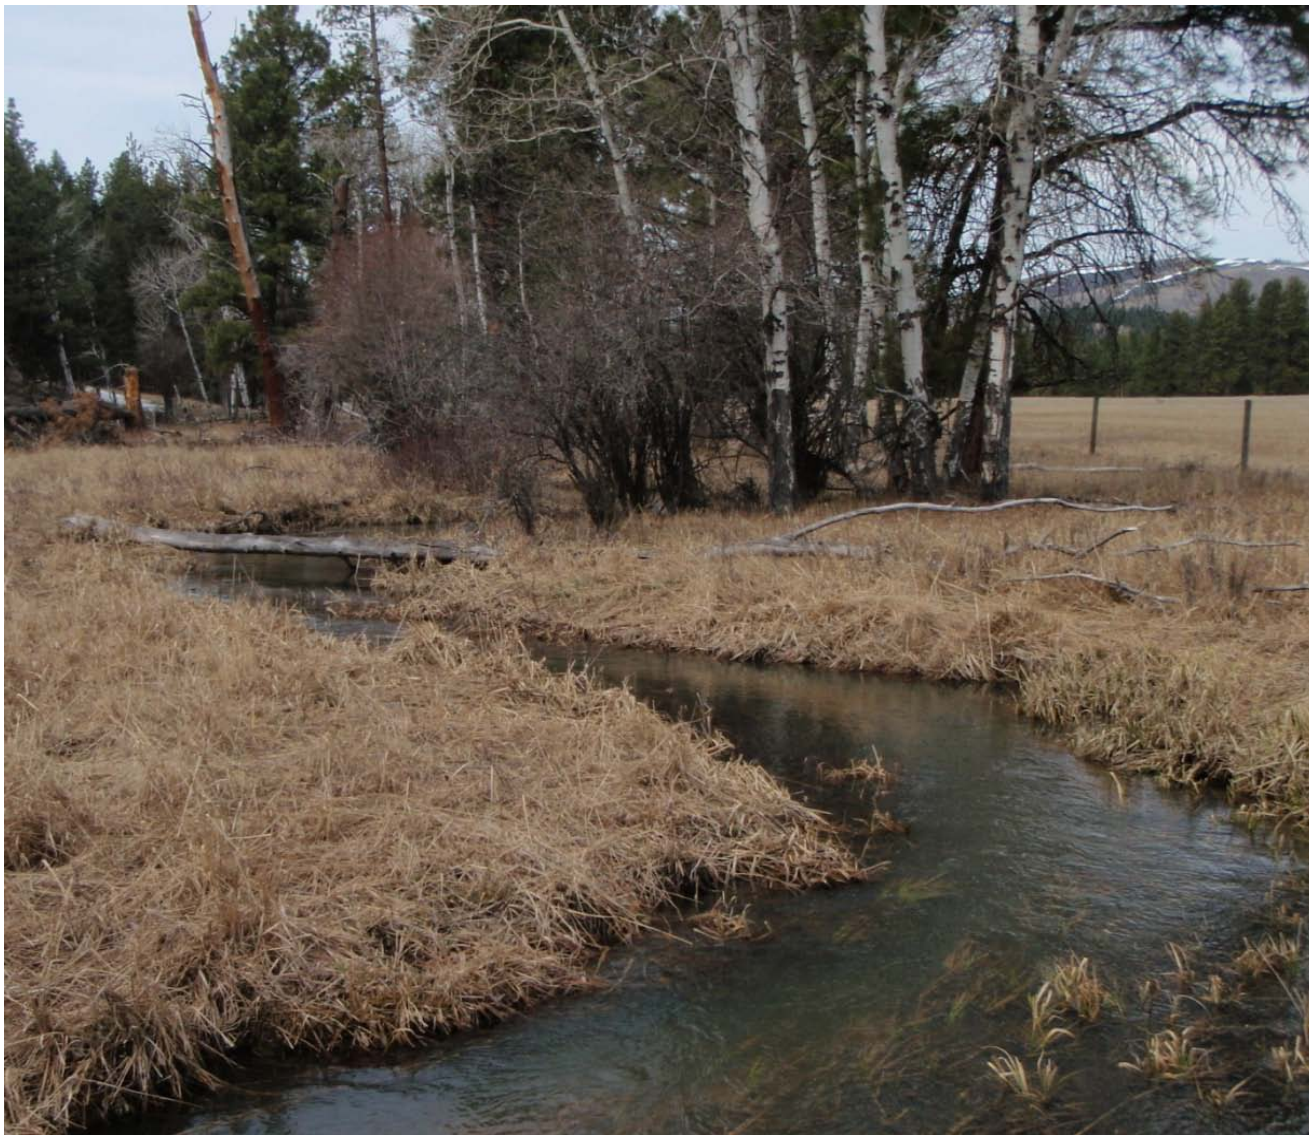
**Photo 4.** Photo of the downstream reference reach taken in April, 2012. The lower portion of treatment (E-channel) stream will construct to similar meandering morphology using vegetative features typical of a small, lower-gradient meadow stream.

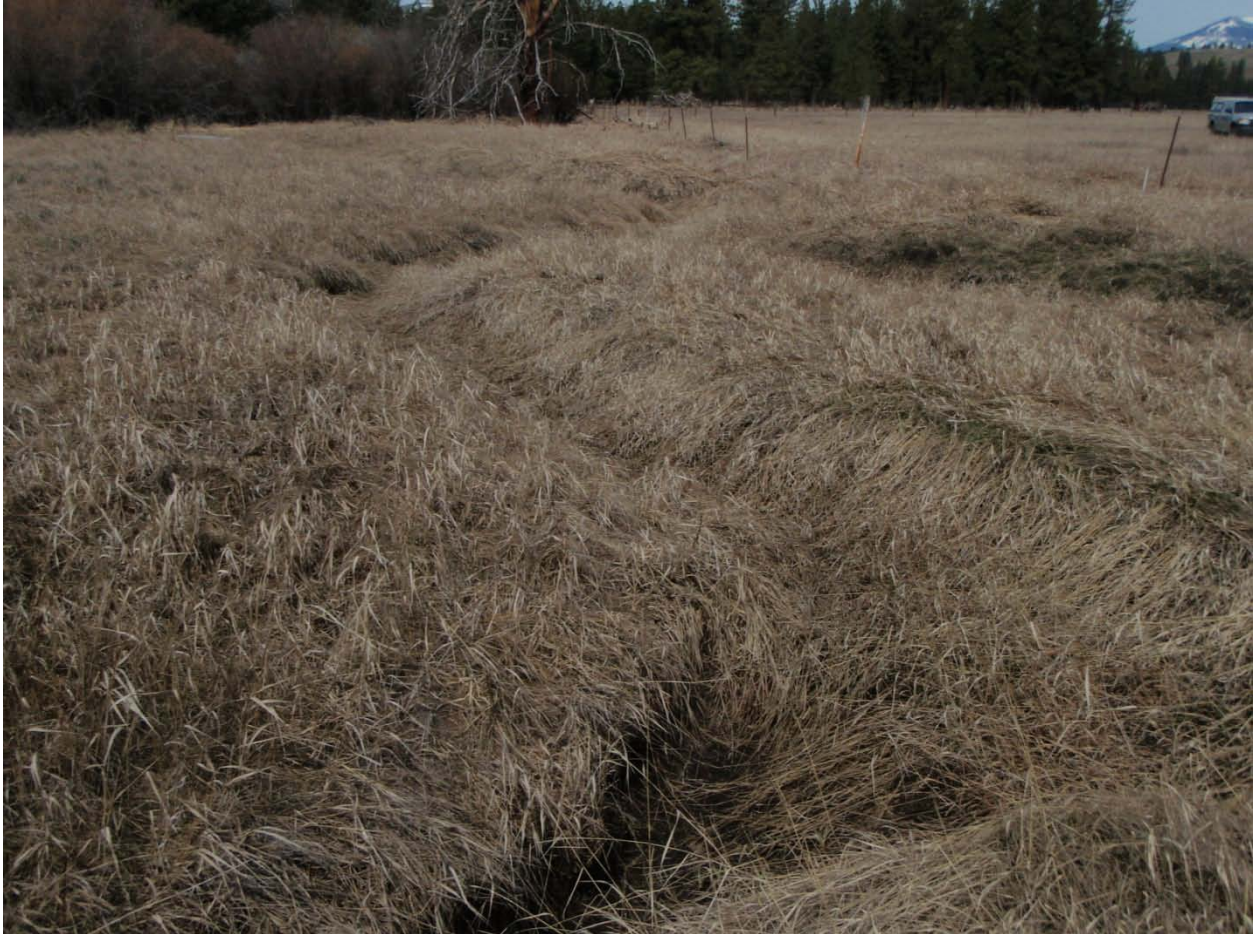
Photo 5: This photo shows a segment of this historical E-type channel just upstream of the county culvert. This segment will be used to the full degree possible.

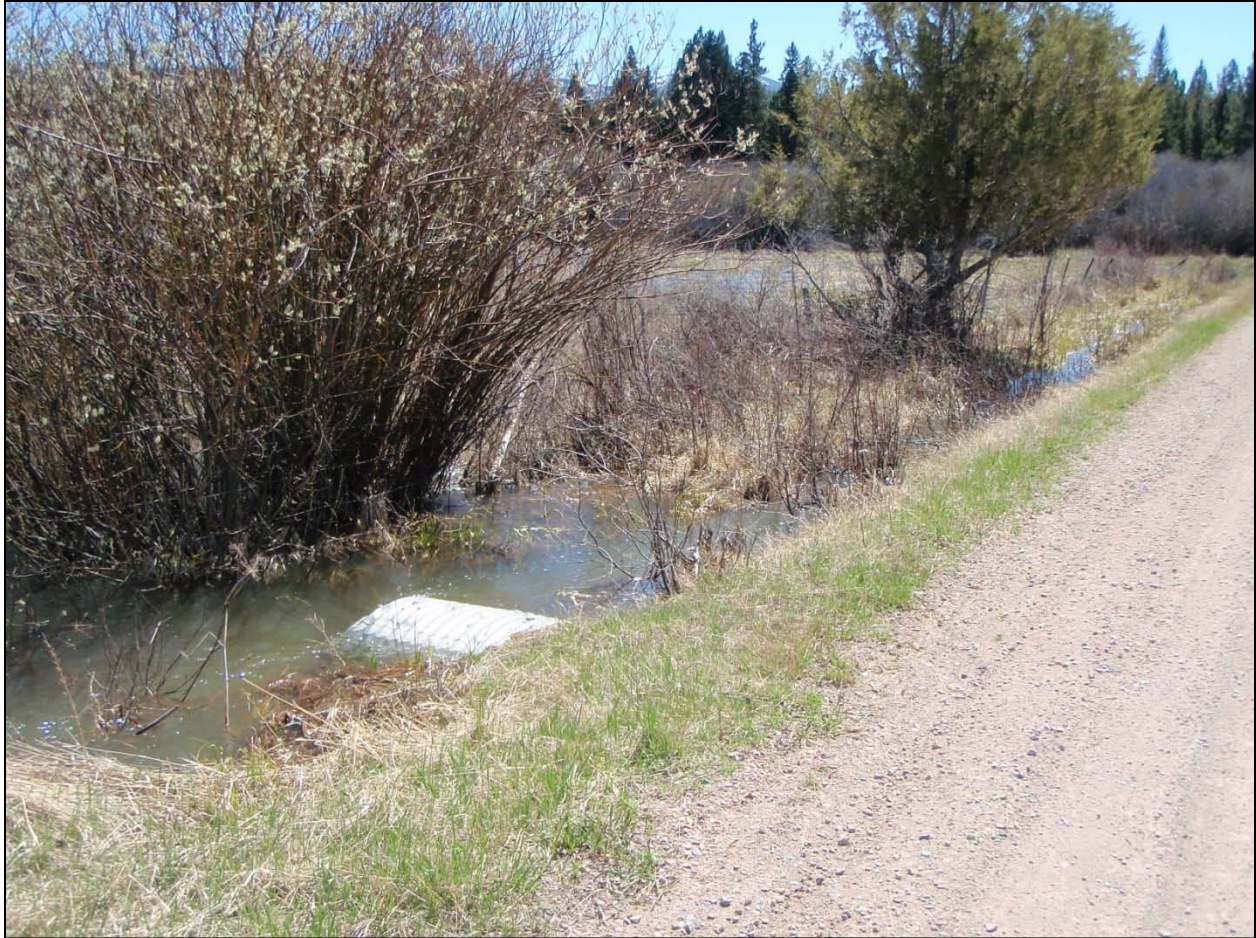
**Photo 6:** This photo shows the undersized culvert. It also shows water flowing down the borrow pit to the culvert. Currently all base flows flow through the borrow pit of road.

Because of the perched location of the channel upstream of the country road, water approaches the culvert crossing from several directions. In addition, the existing 42" x 28" x 30' culvert is hydraulically undersized, impedes fish passage, and contributes to periodic flooding of the country road (photo 6). For the road crossing portion of the project, we are working closely with Powell County Road Department to upgrade the culvert to a 7' span x 4' rise x 36' long concrete box culvert. The new box culvert will have a natural stream bottom and accommodate bankfull dimension and discharges up to a 100-year event. At least one additional floodplain culvert is also planned at this site. Refer to *Pearson Creek Culvert Plan & Elevation View* drawing included in the Appendix.
